# Manhole Inspection Summary

Manhole # S250O1019MH

Insp Date: **12/18/06 2:22 PM**

**Location** Address: **302 WOODLAWN RD**

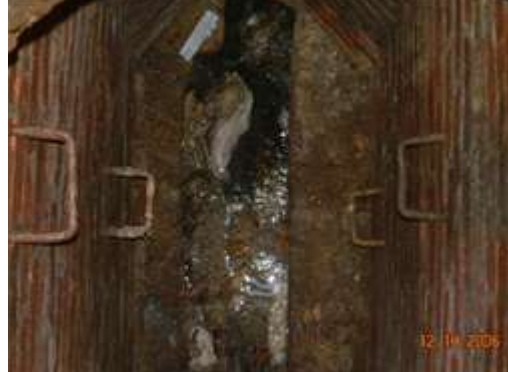
Top View

**Steps** Count: **4** Missing: **0** ☒ **Corroded**

**Surcharge** ☒ **Evidence Of Surcharge** Depth: **3** (ft.) ☐ Active Surcharge Present

Corroded steps. Evidence of surcharge - Bench debris. Channel debris.

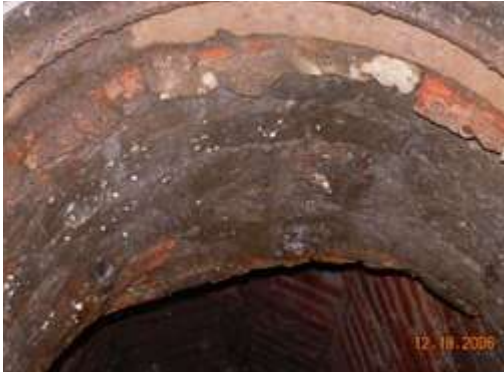
Defect

**Frame** Offset: **0** (in.) Condition: ☐ Sound ☐ Cracked ☒ **Leaks**

Condition: ☐ Sound ☐ Cracked ☐ Root Intrusion ☒ **Loose Brick** ☒ **Deteriorated**

Infiltration: ☐ None ☒ **Joint** ☐ Cracks ☒ **Mortar** ☐ Roots ☐ Wall

Frame leaks. Adjustment deterioration, loose brick and infiltration.

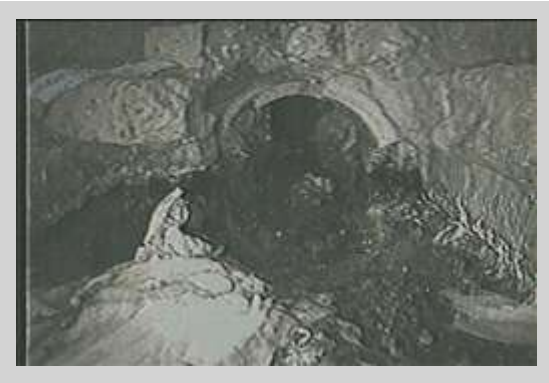
### 6 in. Circular Gravity Sewer Pipe Out @ 12 O'Clock

Barrel deterioration and infiltration. Channel deterioration and root intrusion.

Deposits: ☐ None ☐ Mud ☐ Sludge ☒ **Debris** ☒ **Grease**

Silt Depth: **2** (in.) Deposits Extent: **Heavy**

Infiltration: **None** Pipe Seal Cond: **Broken**

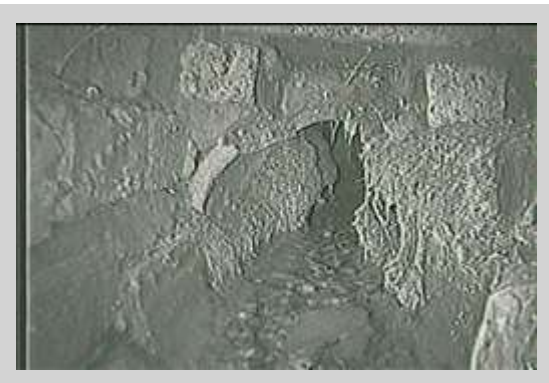
### 6 in. Circular Gravity Sewer Pipe In @ 6 O'Clock

Channel deterioration and root intrusion.

Deposits: ☐ None ☐ Mud ☐ Sludge ☒ **Debris** ☒ **Grease**

Silt Depth: **0** (in.) Deposits Extent: **Heavy**

Infiltration: **None** Pipe Seal Cond: **Broken**
